# **Te Rere Hau Windfarm Annual Noise Monitoring Report**

**2021—2022**

**Adam Fuller**

**Engineer, TRH Services**

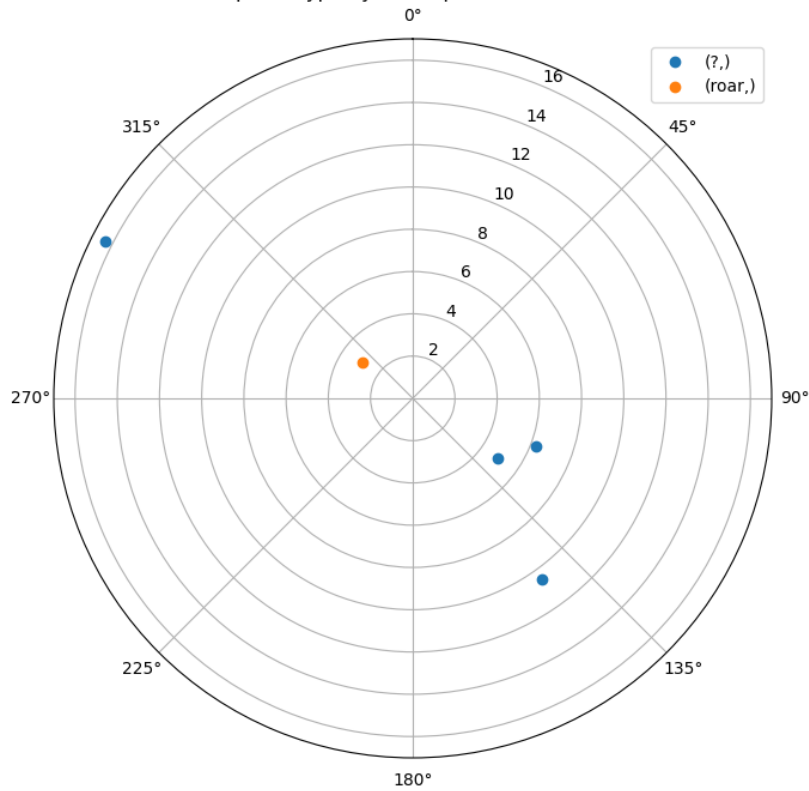
Noise complaint type by wind speed and direction, 2021

The figure below shows all complaints categorized based on the text of the complaint and plotted according to the wind speed and direction at the time of the of the complaint.

Generally, for the affected residents, “roar” noise is heard in easterly winds and “woosh” noise in westerly winds.

After the 25 Nov complaint blade repairs were carried out on T86 and T87 by 3 Dec which may well have solved the unusual noise for those on Ridgeview Road.
