Te Rere Hau Windfarm Annual Noise Monitoring Report

2022—2023

Adam Fuller

Engineer, TRH Services

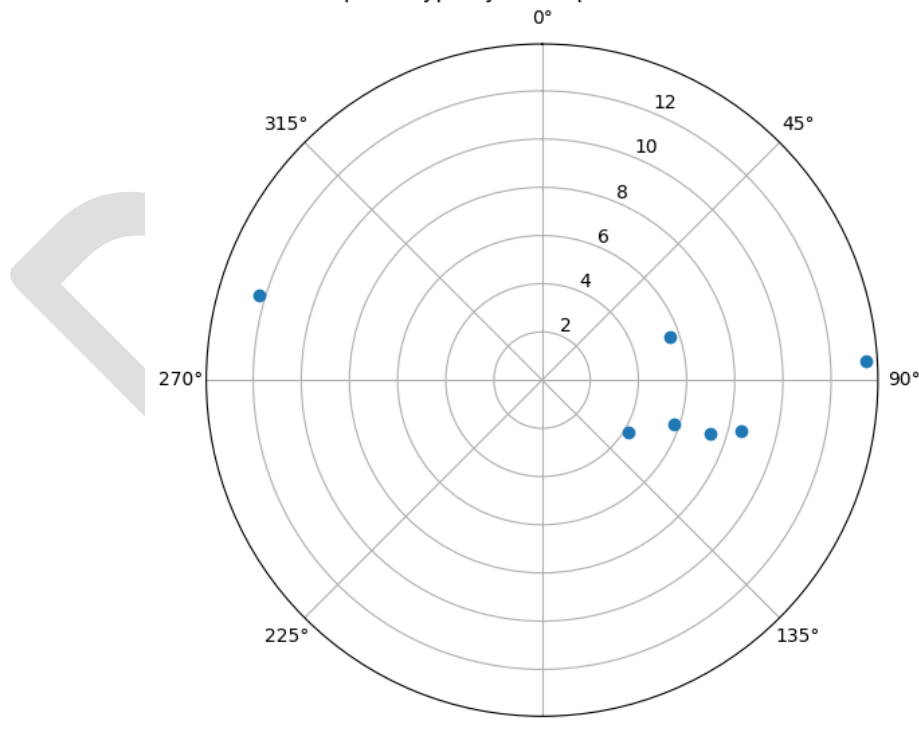
Noise complaint type by wind speed and direction, 2022

The figure below shows complaints plotted according to wind speed and direction.
